Extra-Oral Sinus Tract

Contributed By: Dr. Mandana Partovi – May 2005

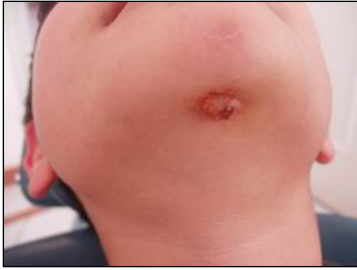
Clinical examination showed a crusty nodule approximately 2 cm in diameter in the submental area (Figure 1). Palpation elicited an exudatous discharge from it.

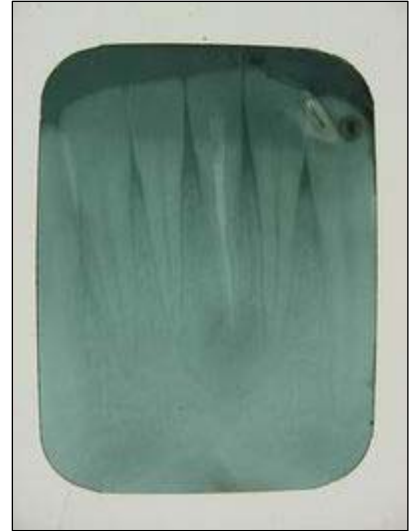
The root canal treatment was completed by obturating the canal with gutta-percha and sealer using the lateral condensation technique, and the final restoration was made with a light cured composite filling (Figure 2).

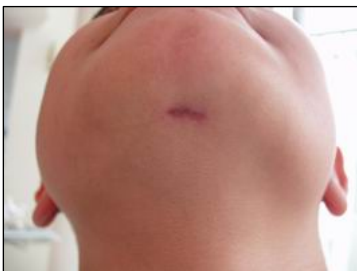
The patient was recalled after 2 months. Clinically the draining lesion had completely healed, with a scar left on the place (Figure 3).

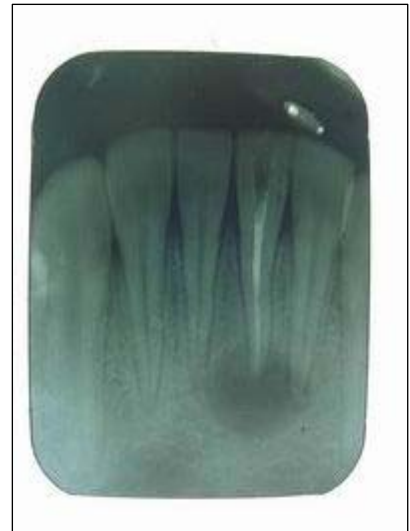
Radiographically, the lesion had healed and a distinct lamina dura was seen surrounding the tooth (Figure 4).
